PERFORMANCE EVALUATION OF IOWA BRIDGE DECKS CONSTRUCTED WITH EPOXY-COATED REINFORCING BARS

Final Report

August 19, 2011

Iowa Department of Transportation

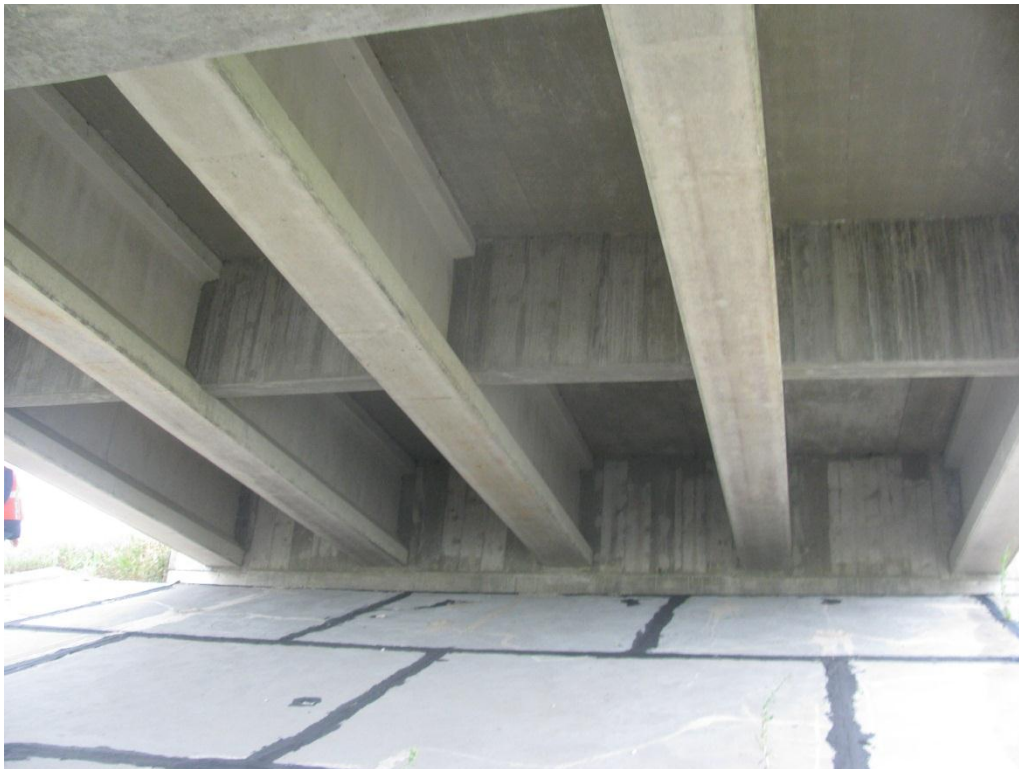
Figure 30. Typical view of IA 17 deck underside

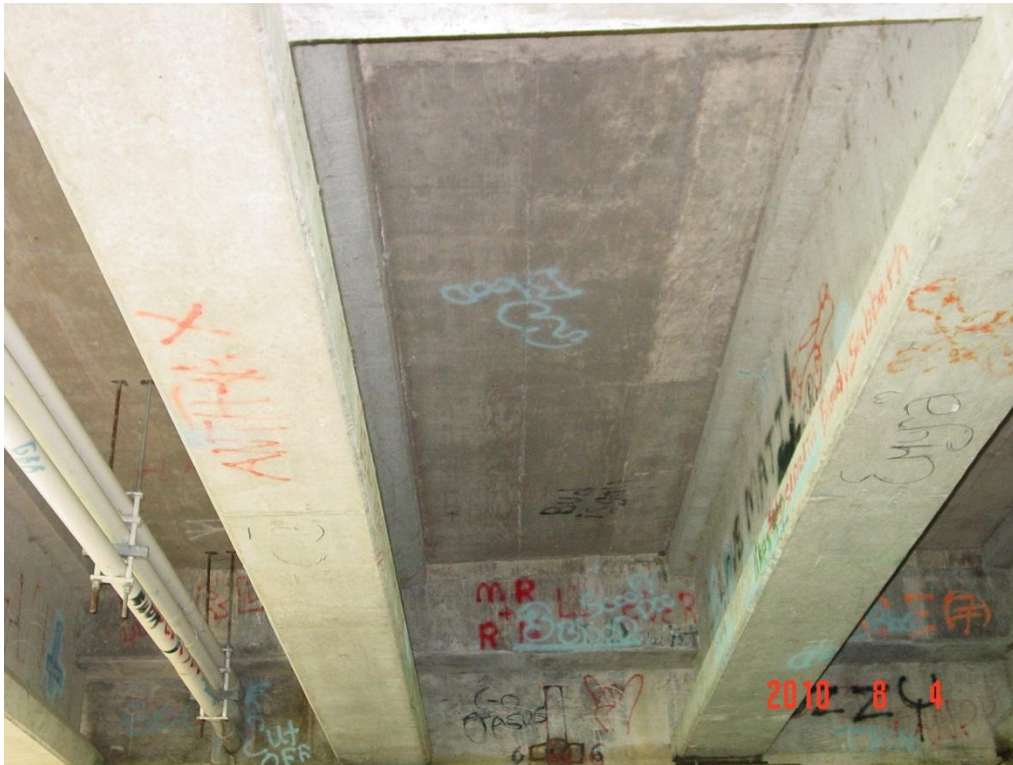
Figure 34. View of underside of IA 150 deck adjacent to the north abutment.

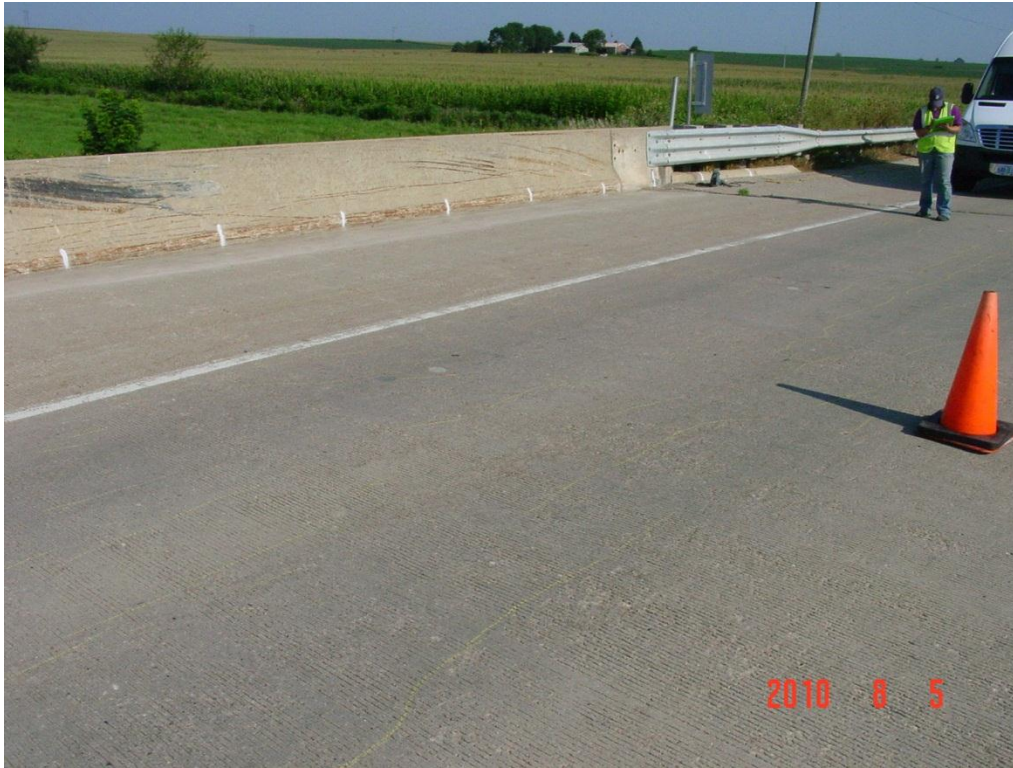
Figure 35. Typical view of top surface of the Southbound Iowa 13 bridge deck.

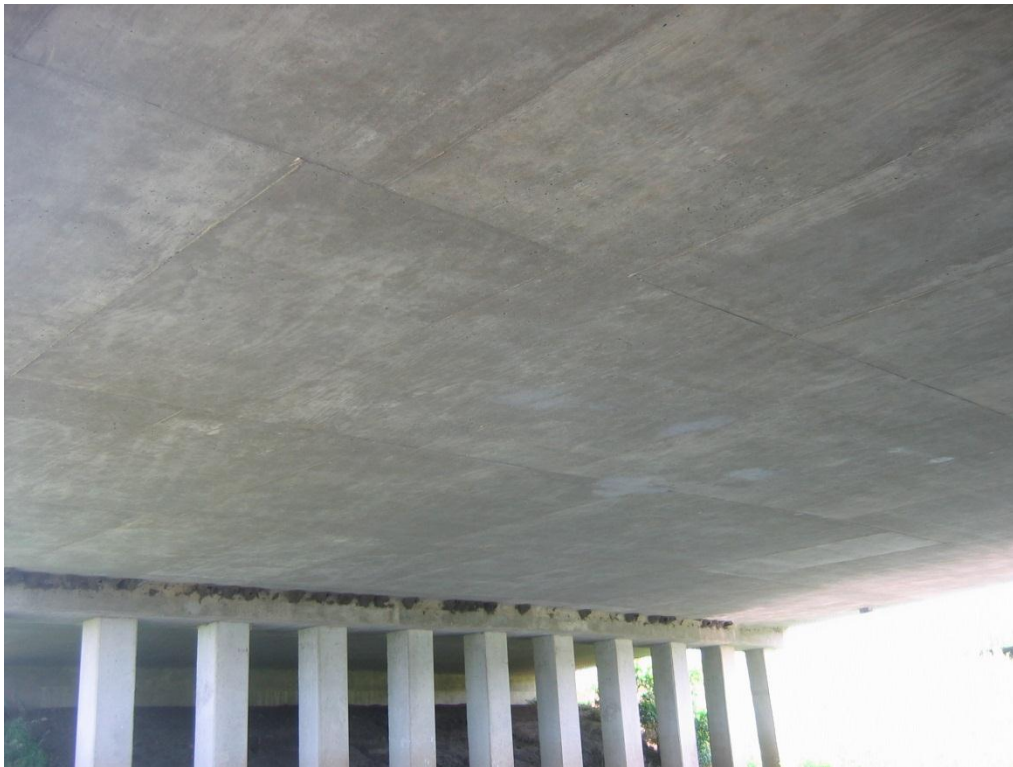
Figure 36. Typical view of the underside of the Southbound Iowa 13 bridge deck.

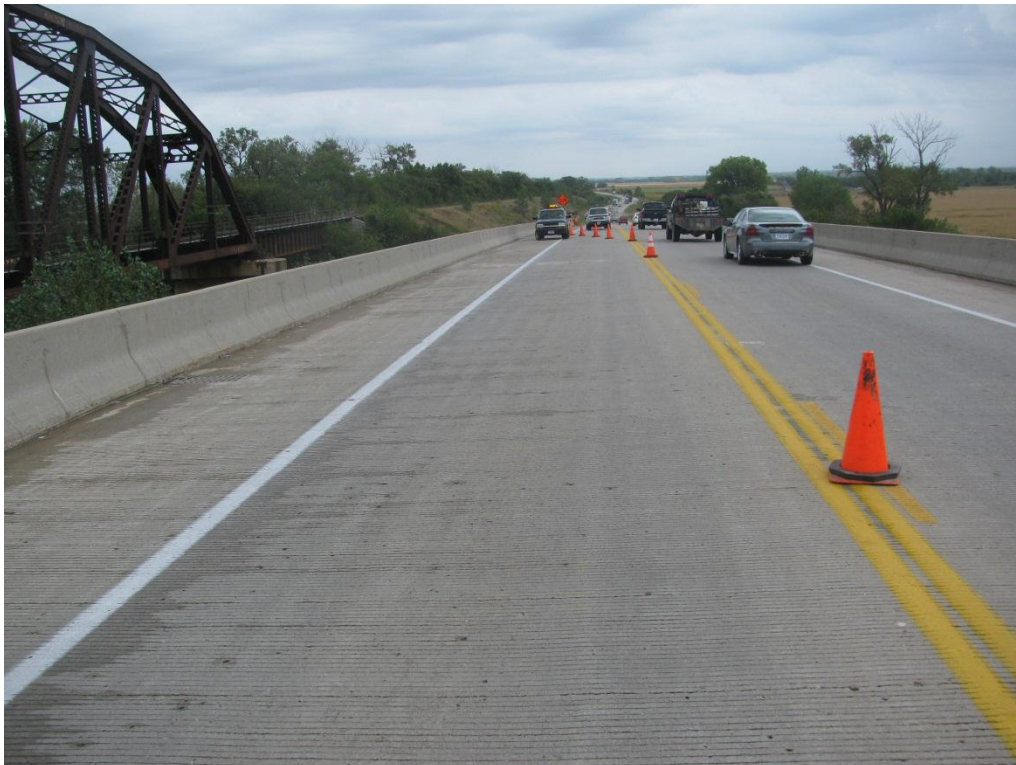
Figure 38. Typical view of US 30 bridge deck in east approach spans.

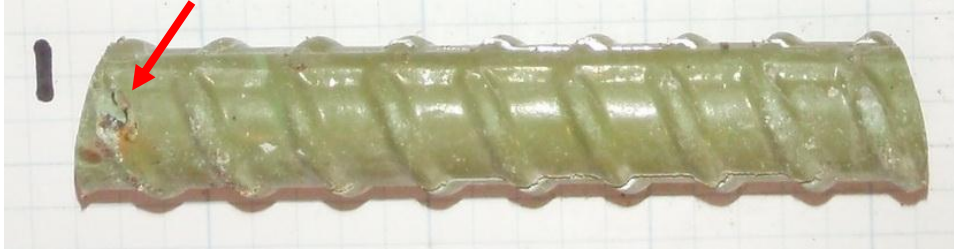
Figure 45. Pre-existing damage to coating of actively corroding bar in Core #2 from US 30 bridge deck (location of damage indicated by red arrow).

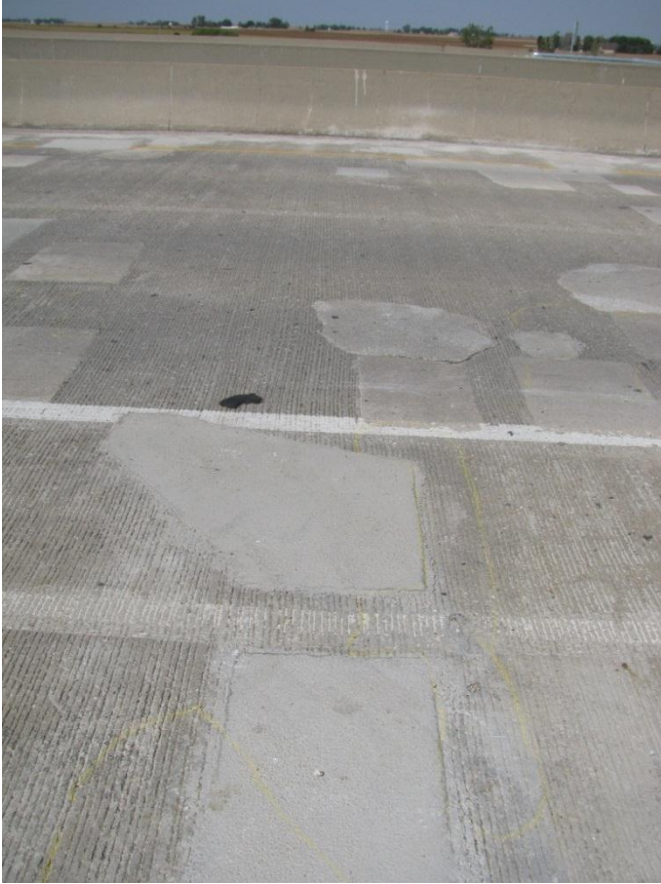
Figure 53. Area of extensive patching on Northbound US 65 bridge deck.

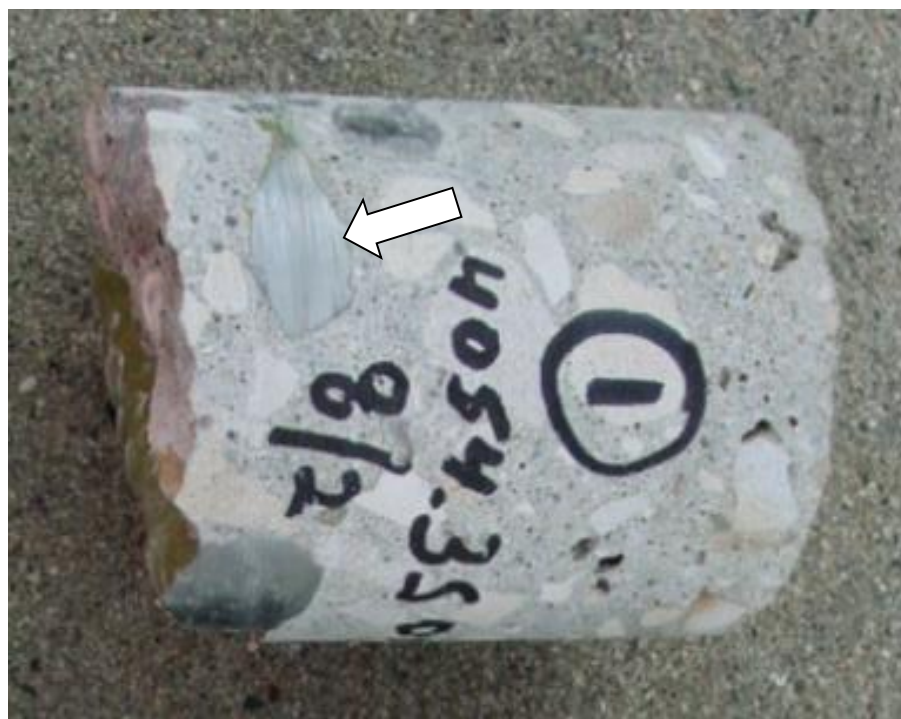
Figure 4. The site photo of the side of Core IA 17 #1 (reinforcing bar identified by arrow).

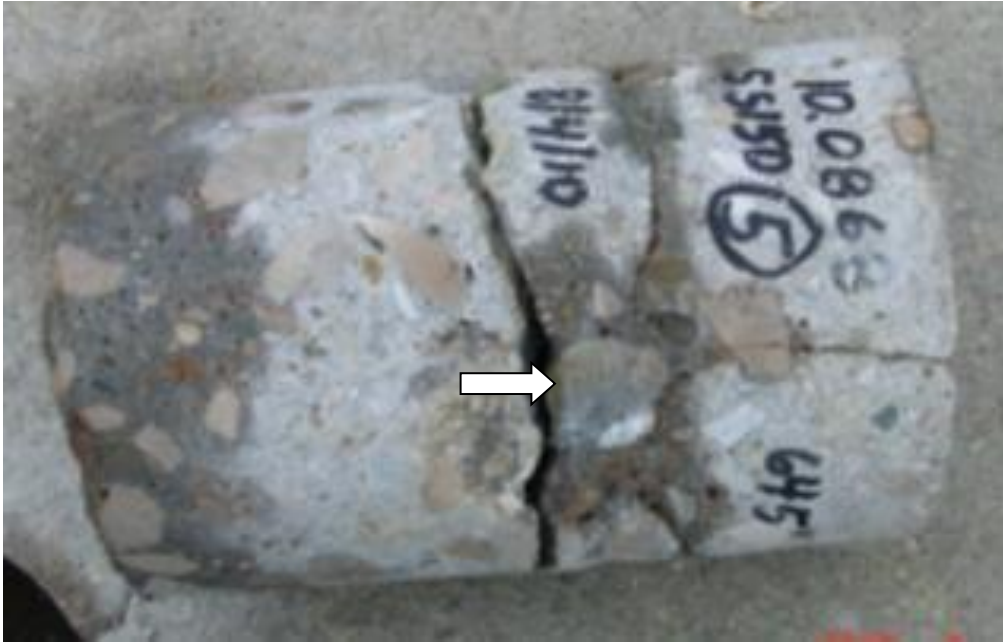
Figure 7. The site photo of the side of Core IA 150 #5. The rebar (arrow) was subsequently removed in the laboratory for examination.

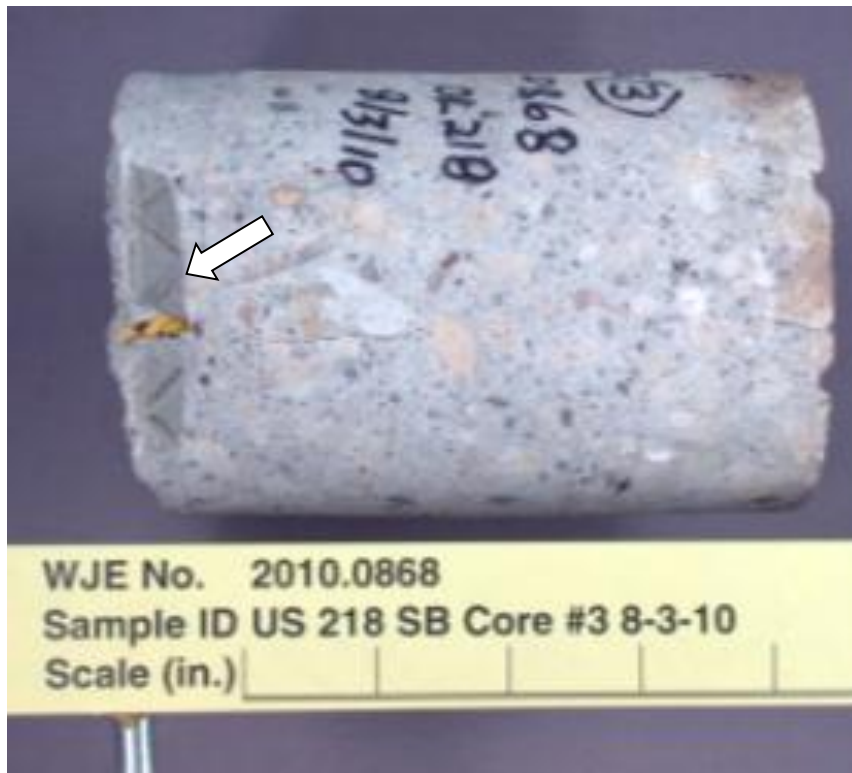
Figure 11. The as-received appearance of the side of Core US 218 SB #3. Note imprint of reinforcing bar at bottom of core (arrow).

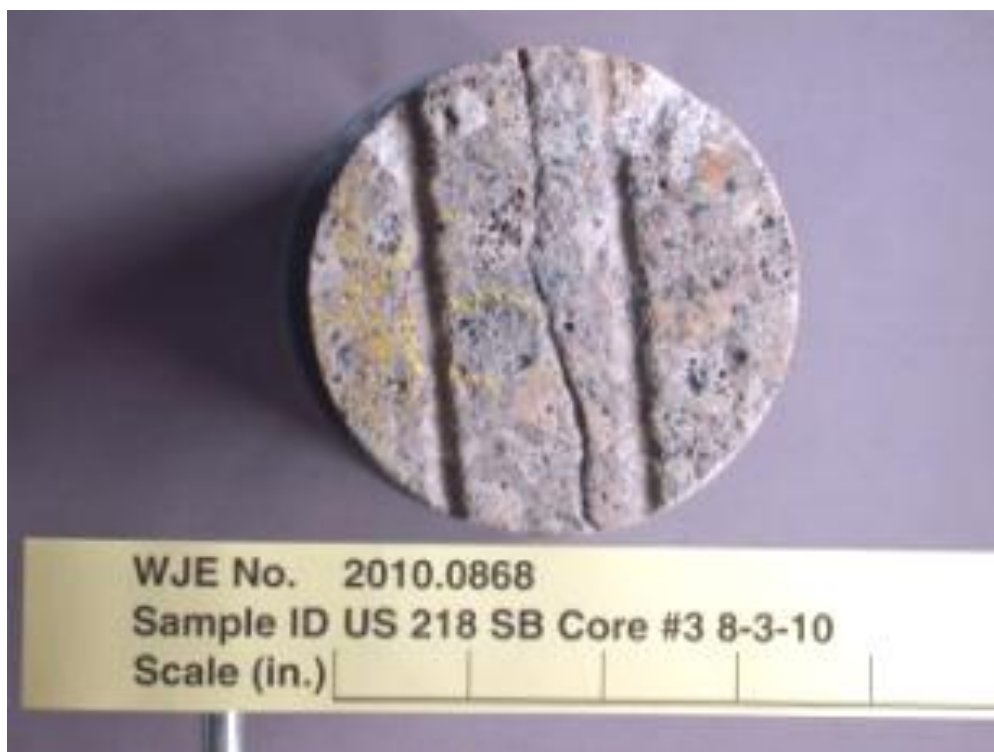
Figure 12. The as-received appearance of the top of Core US 218 SB #3 using low angle lighting to emphasize crack and tinting on top surface.

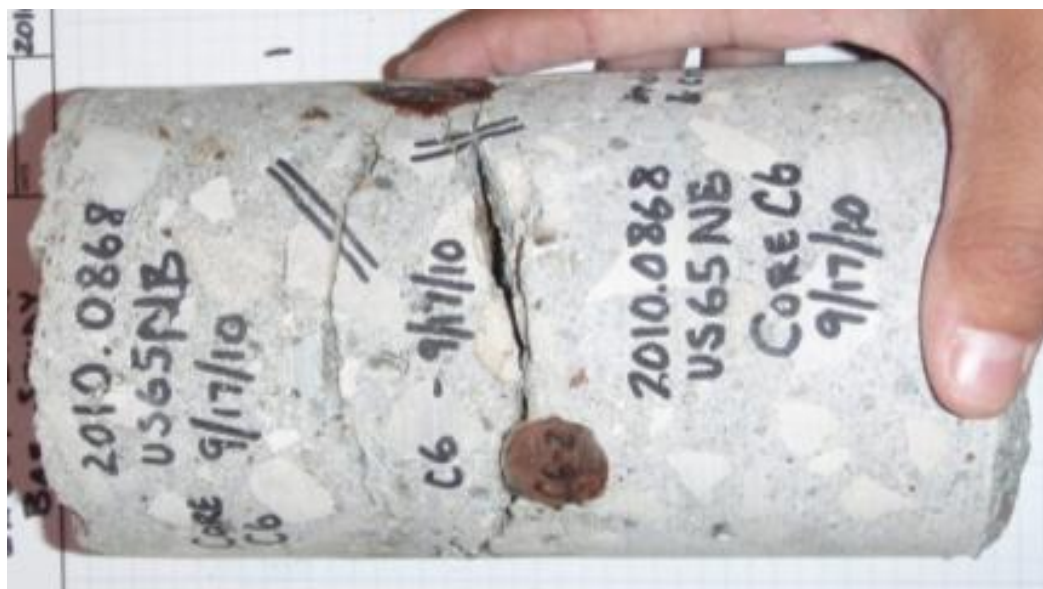
Cracks in Cores IA 150 #5 and US 65 NB #6 appear to be associated with corrosion of embedded steel (see Figures 5 and 24). Also, in the case of Core IA 150 #5, additional opening of the crack may be associated with deposition of silica gel (Figure 44).

Figure 24. The site photo of the side of Core US 65 NB #6. The rebar was subsequently removed in the laboratory for examination.

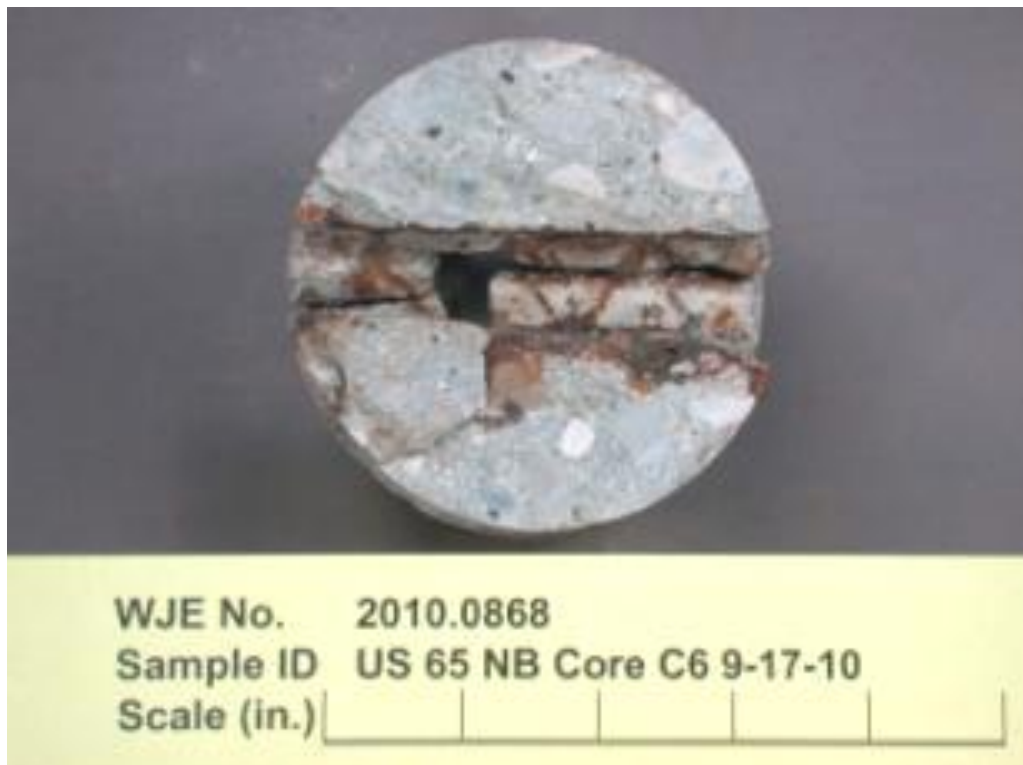
⁷ Multiple cracks associated with embedded steel reinforcement. See Figures 24 and 27.

Figure 27. The as-received appearance of the bottom of the top section of Core US 65 NB #6 showing multiple cracks at the location of the removed reinforcing.
